L1190205027-Madison Co.
Gibraltar Manufacturing
IL 0000034322
SF/HRS

CERCLA Integrated Site Assessment

**Illinois Environmental
Protection Agency**

The Illinois Environmental Protection Agency's Site Assessment Unit was tasked by Region ⁵ V of the United States Environmental Protection Agency (U.S. EPA) to conduct a CERCLA Integrated Assessment (IA) of Gibraltar Manufacturing (IL# 0000034322) in Madison County, Illinois.

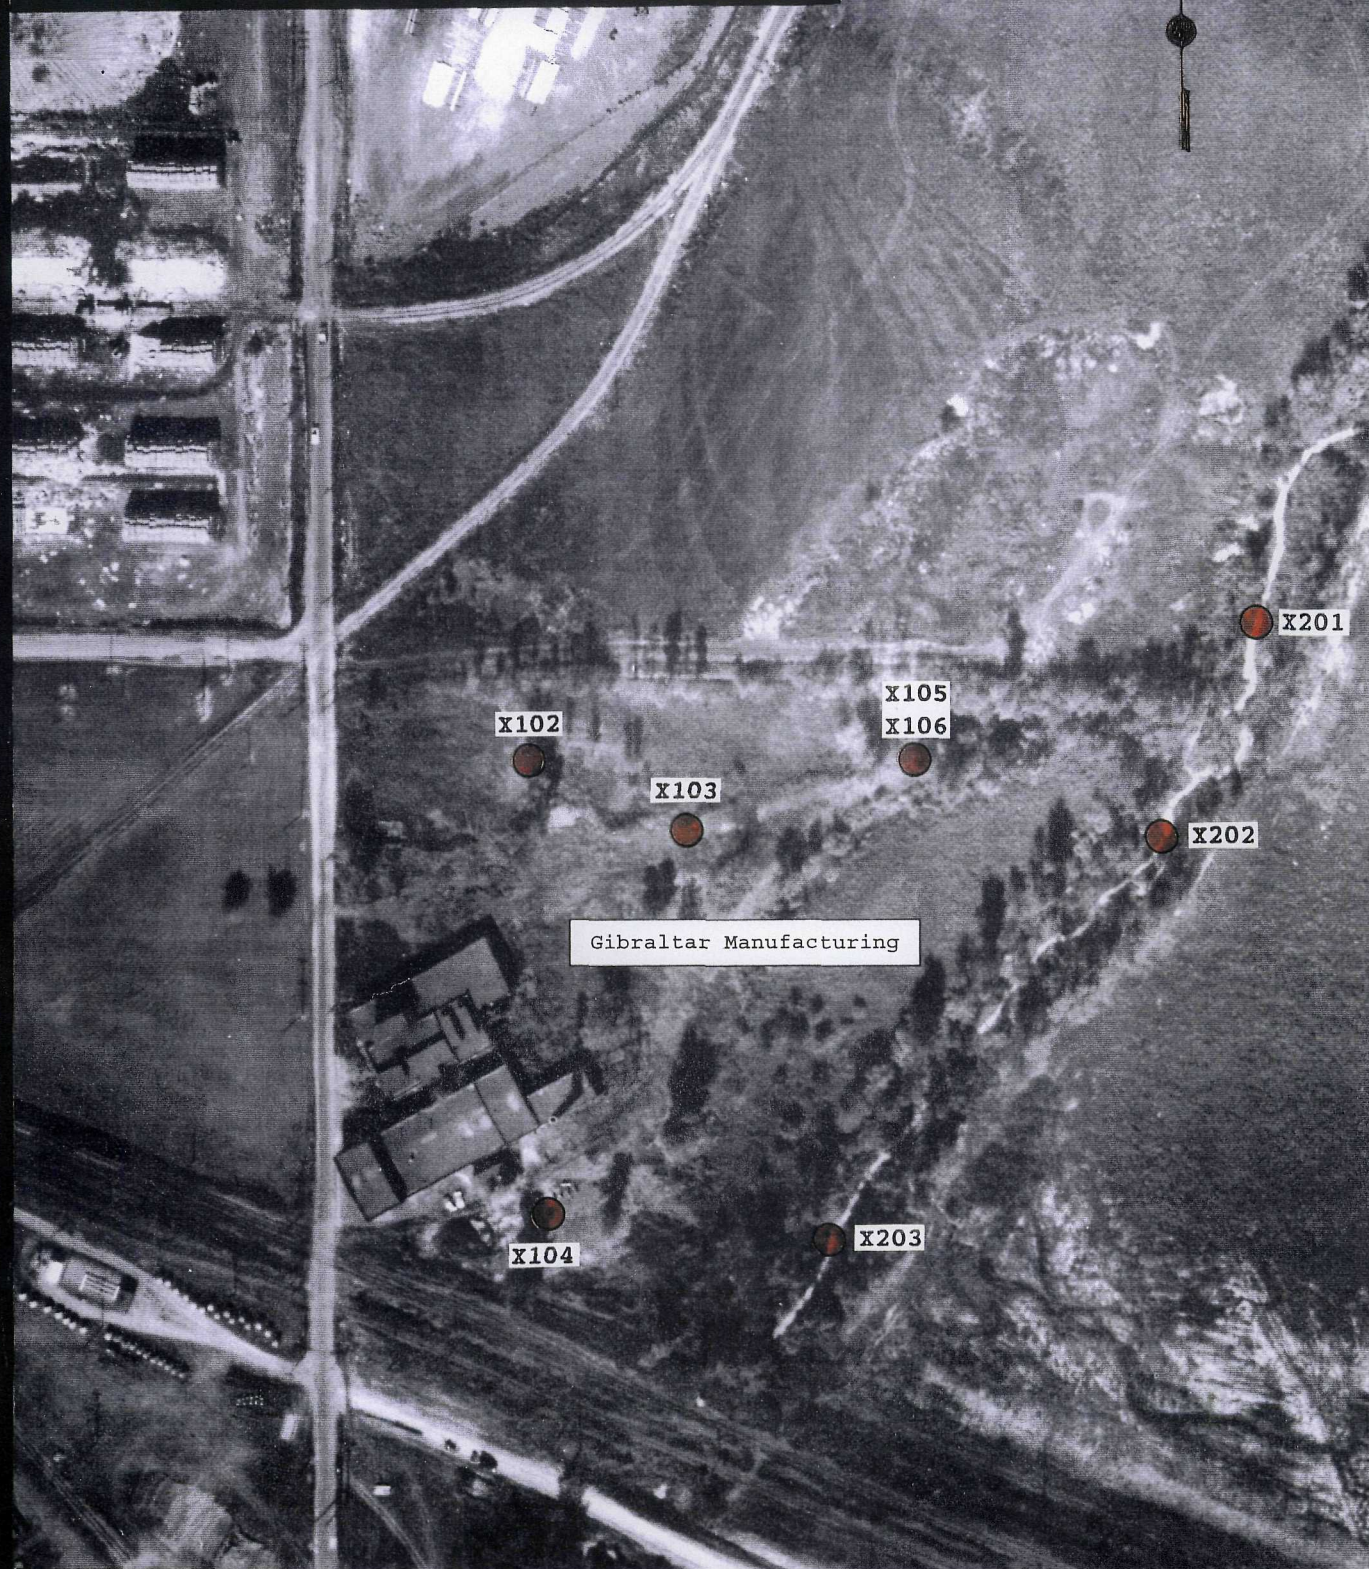
Figure 3-2

Sampling Point: ●

Background sediment sample X201 was taken 51' north (upstream) of the Gibraltar property. It was collected from the west bank of unnamed perennial stream that borders the property to the east. This point was chosen for the background due to the fact that the sediment type is the same as those found in the downstream sediment samples.

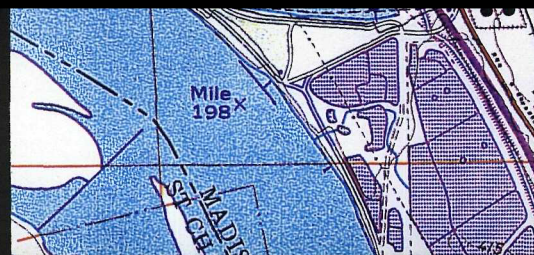
ILLINOIS ENVIRONMENTAL PROTECTION AGENCY	Gibraltar Manufacturing 0000034322
GROUNDWATER & SURFACE WATER SAMPLES	
Scale 1:24,000	Sampling Point: ●

property line of the site. Figure 3-3 is a map identifying the location of the surface water samples. The required preservatives were added to the containers after the samples were obtained.

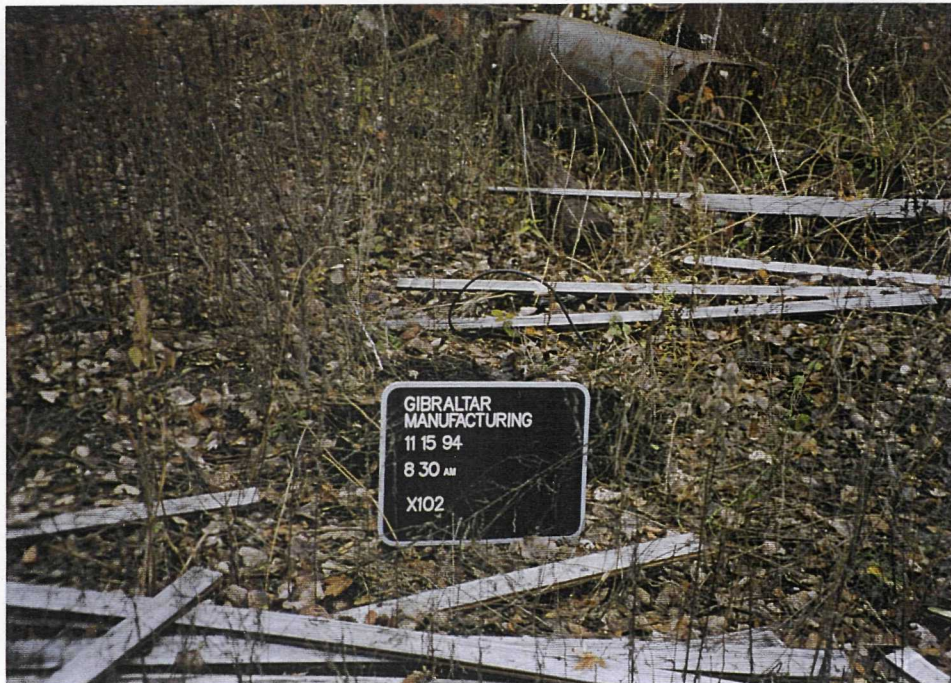
PHOTO TAKEN TOWARD:
North

Soil sample X102 was taken from the top 12 inches of soil. This sample was collected in the area where a leaking capacitor was observed. Analysis of this sample revealed the presence of semi-volatiles, PCBs, and inorganic compounds. The Removal

Soil sample X102 taken
from the area in which
the leaking capacitor
was observed.

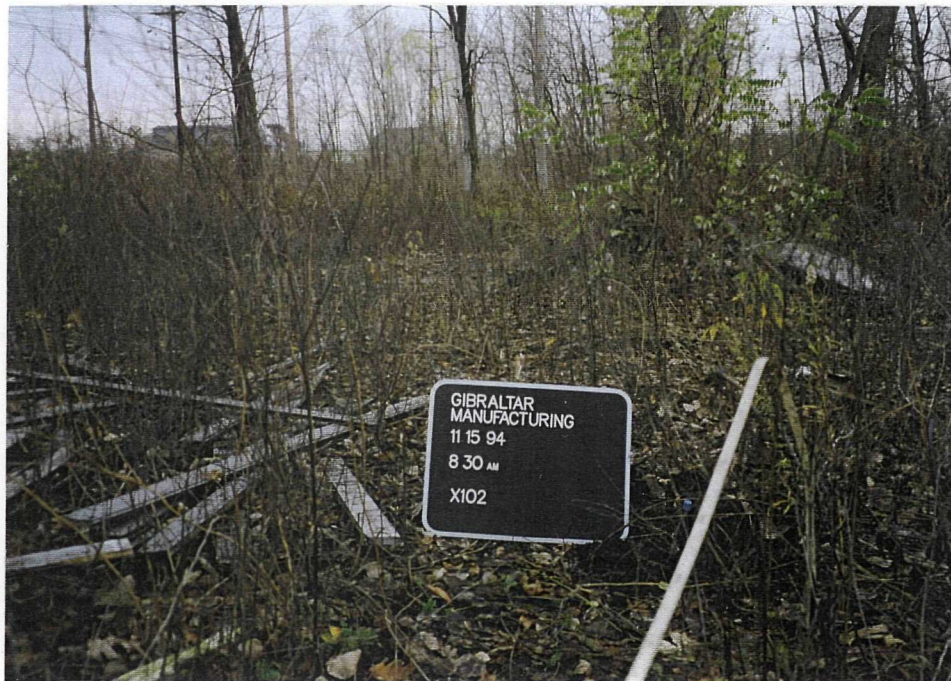
PHOTO TAKEN TOWARD:
West

Sampling point X102 from
a different perspective.

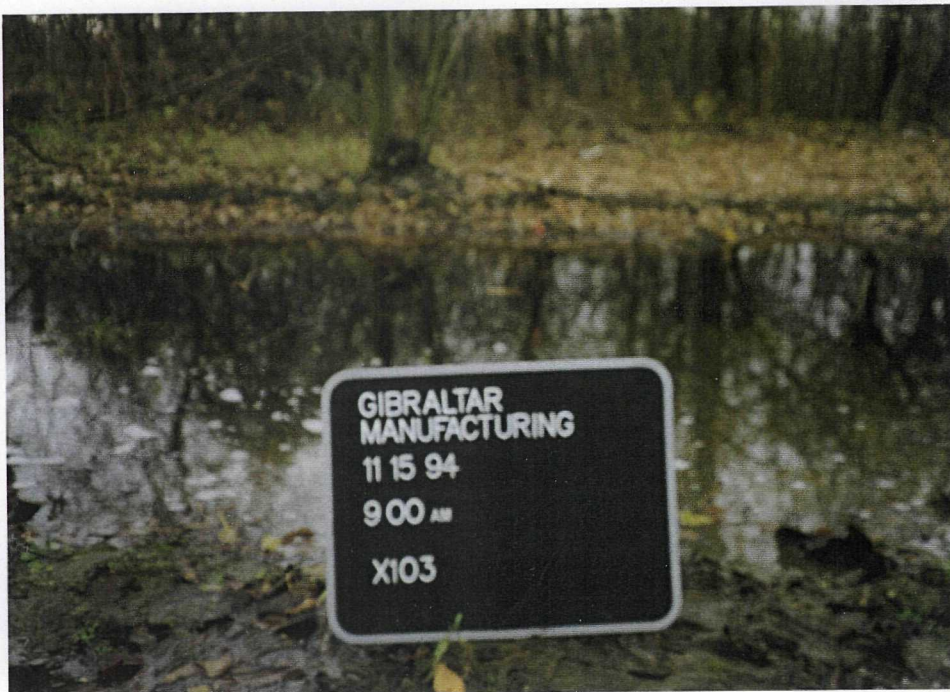
PHOTO TAKEN TOWARD:
West

Close up of sample X103
collected from an area
where contaminated soils
were identified and
removed.

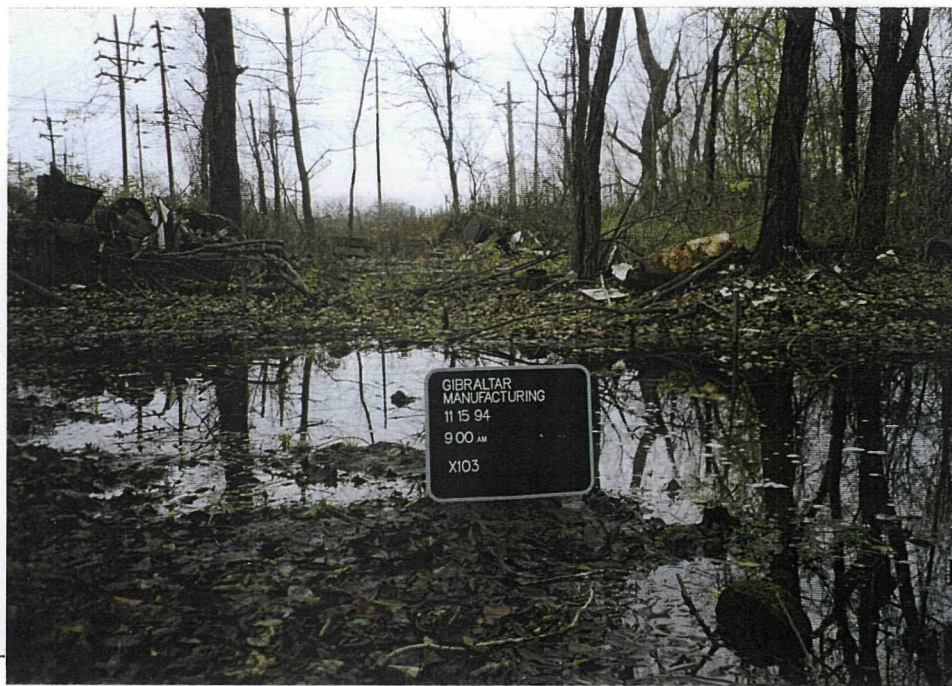
PHOTO TAKEN TOWARD:
South

Sample X103 collected in
the area from which
contaminated soils were
identified and removed.

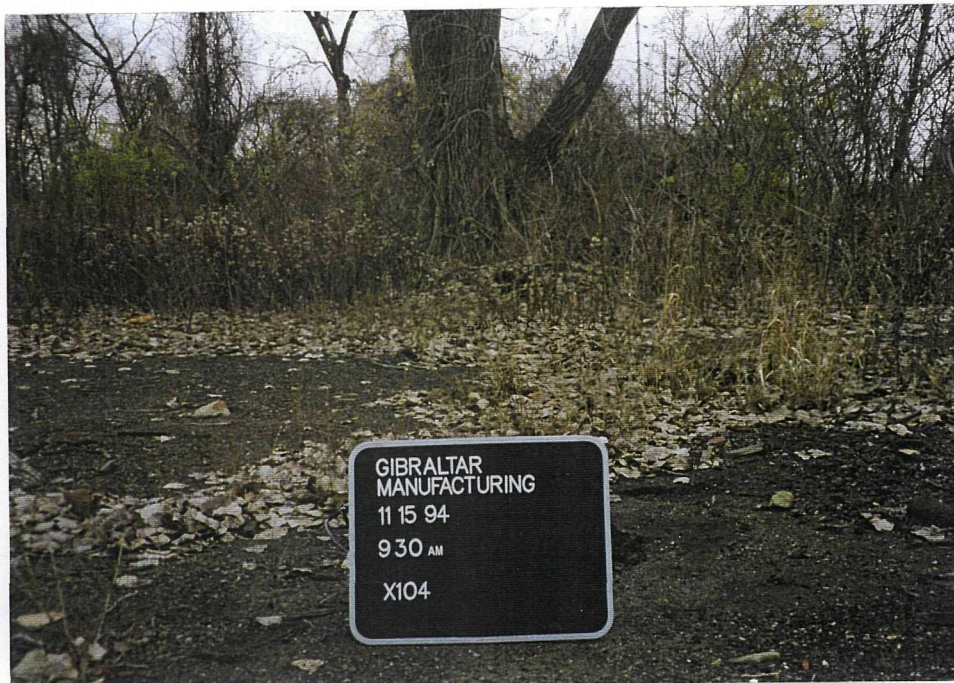
PHOTO TAKEN TOWARD:
South

Sample X104 collected
from an area in which
drums were dumped and an
above ground storage
tank was located.

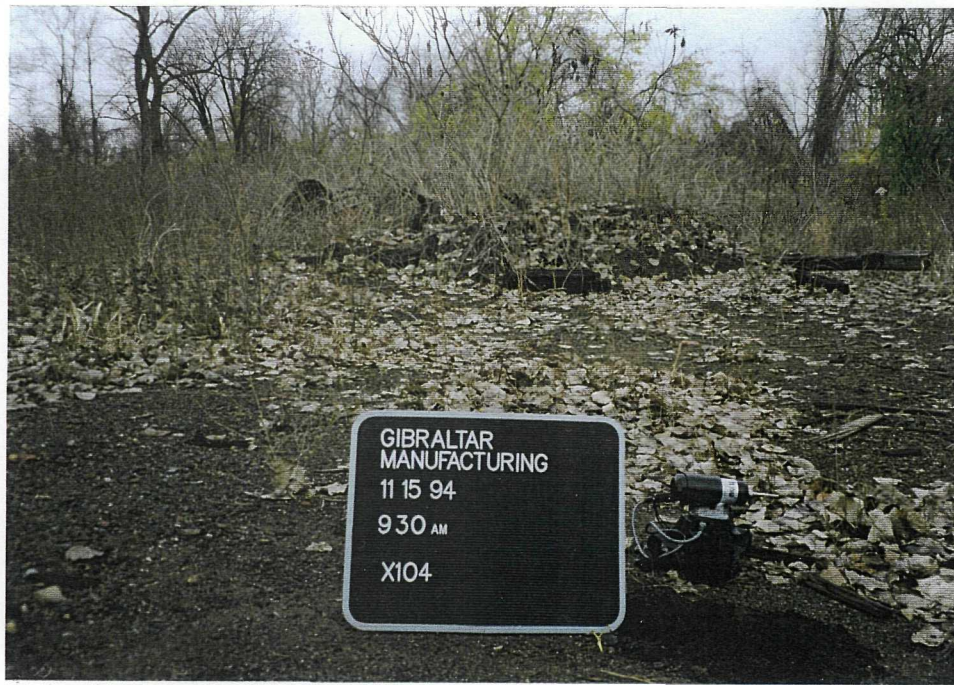
PHOTO TAKEN TOWARD:
East

Different perspective of
sample point X104.

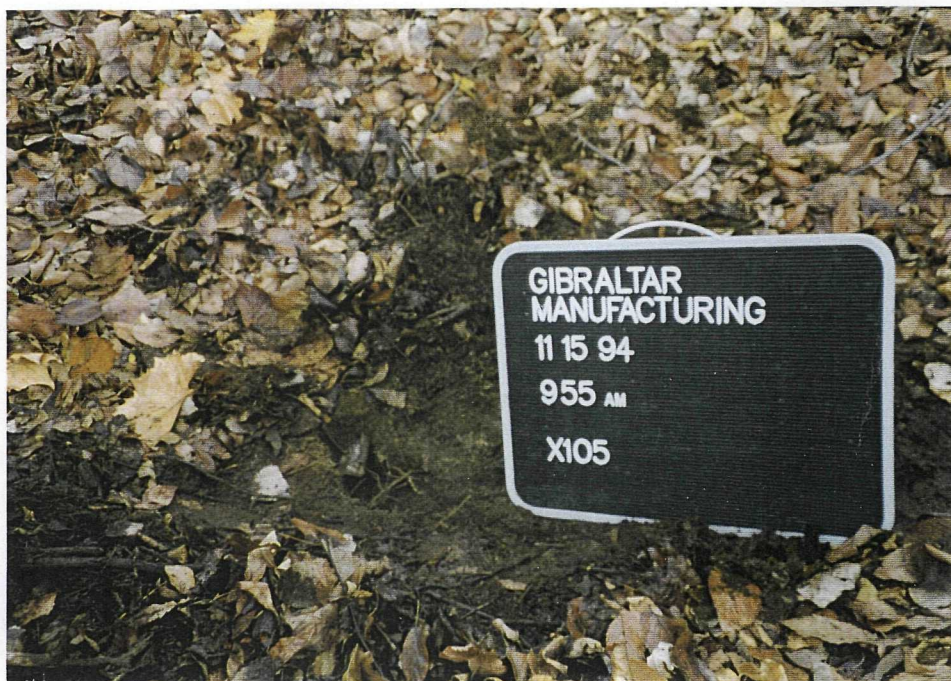
PHOTO TAKEN TOWARD:
North

migrated to the wetland area. After the volatile samples were collected and sealed, the media was mixed in a stainless steel pan in order to obtain proper duplicate samples. The sample was obtained from the top 12 inches of soil. Analysis of these samples revealed pesticides, PCBs, and some inorganic contaminants.

Close up of duplicate
samples X105 & X106
collected from a wetland
area on the property.

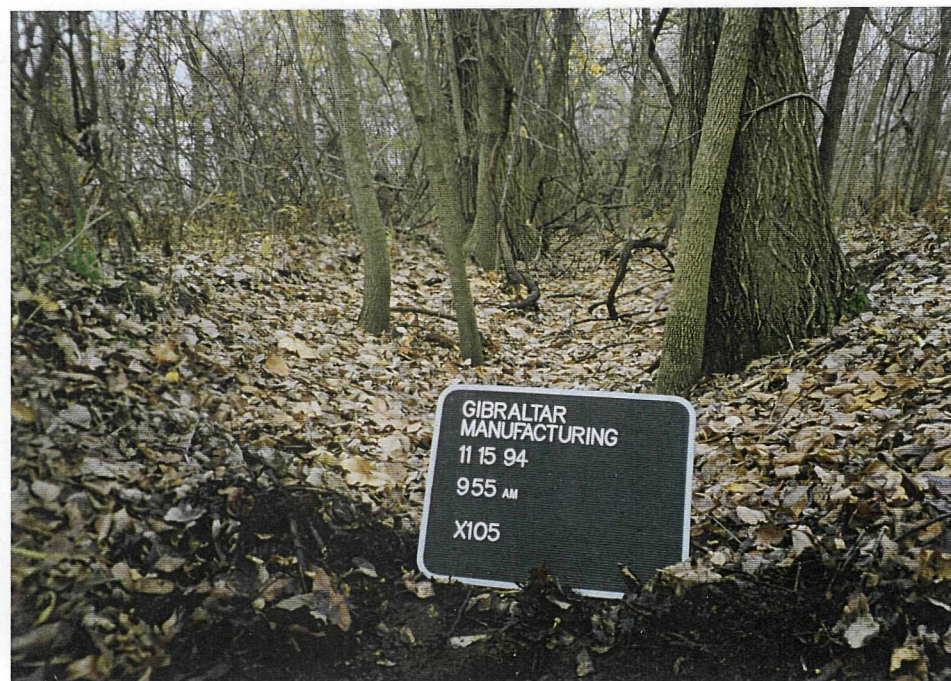
PHOTO TAKEN TOWARD:
West

Duplicate samples X105 &
X106 taken along a
drainage pathway in the
wetland area on the
property.

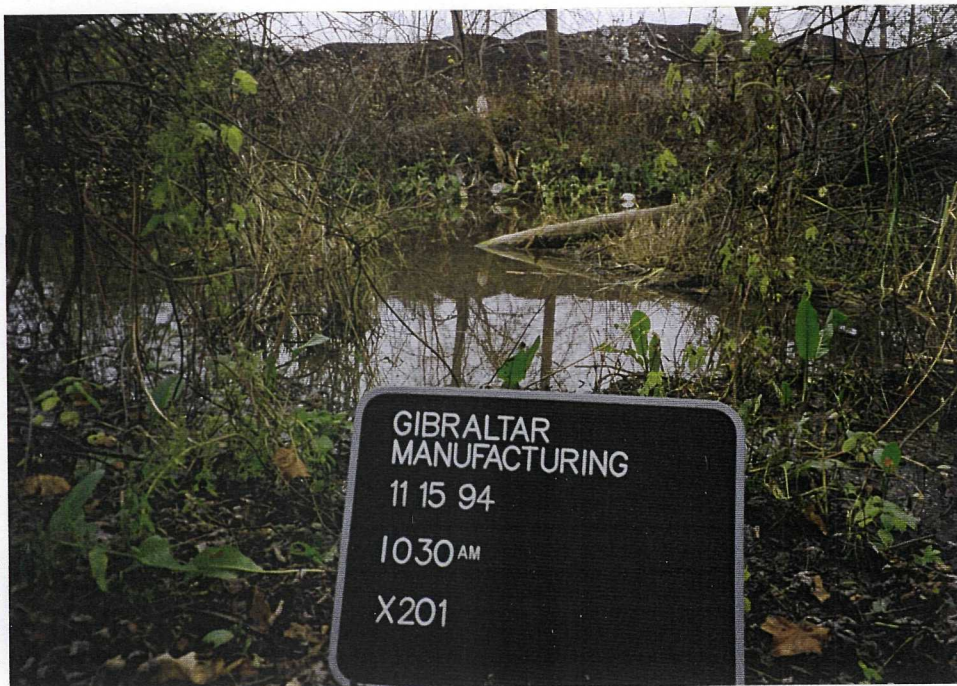
PHOTO TAKEN TOWARD:
East

Background sediment
sample X201 with the
Laclede Steel Landfill
to the east.

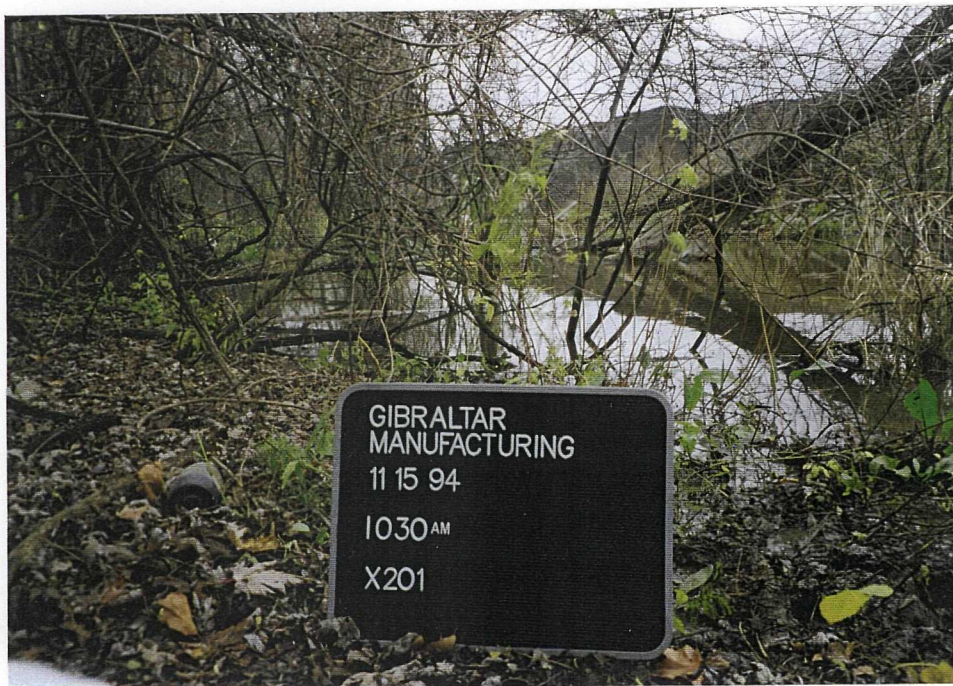
PHOTO TAKEN TOWARD:
North

Background sediment
sample X201 with
upstream segment of the
surface water pathway in
the background.

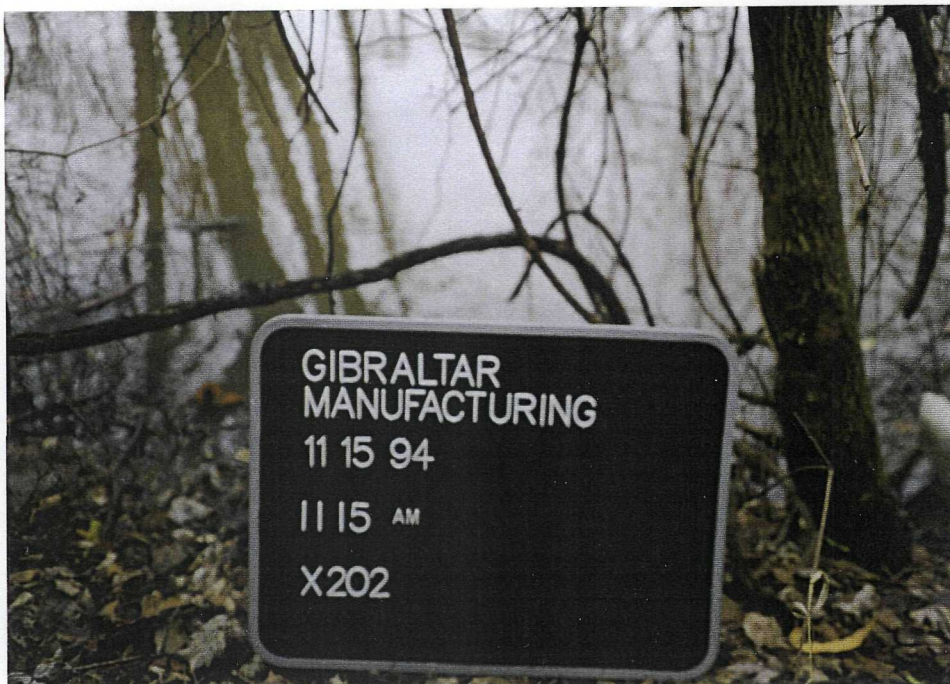
PHOTO TAKEN TOWARD:
East

Sediment sample X202 was taken from the west bank of the stream that borders the site as well. During the initial site recon, leachate was observed seeping from the Gibraltar property into the stream. The intent was to obtain the sample in the area of the leachate seep. Due to heavy rains prior to the sampling event this proved impossible to do. The sample was taken from the top 12 inches of sediments. Analysis of X202 revealed contaminants similar to those in the background. The RALs for arsenic and cadmium were exceeded in X202.

Close up of sediment
sample X202.

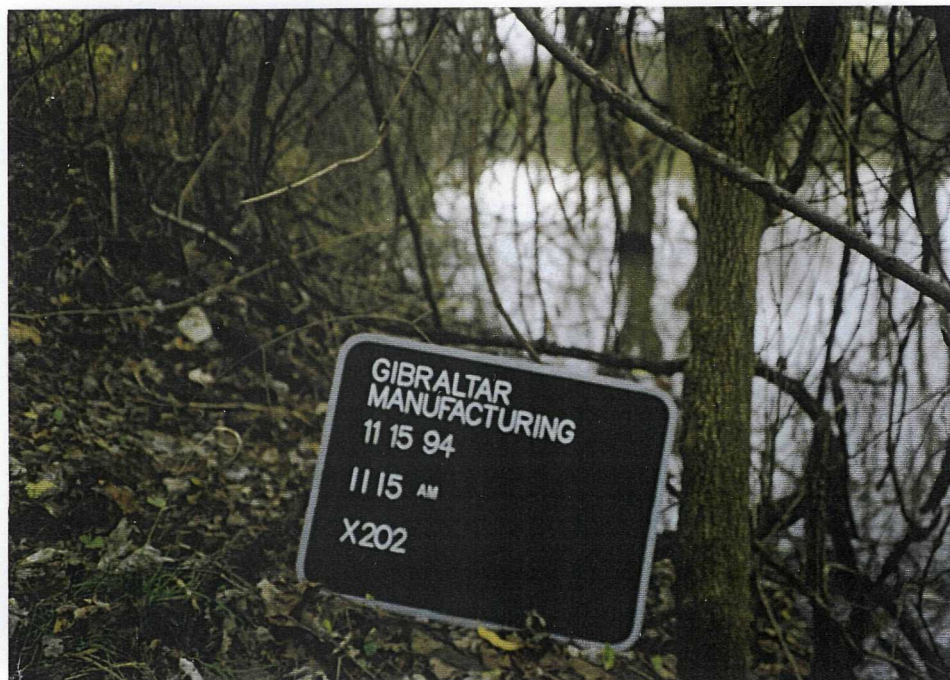
PHOTO TAKEN TOWARD:
North

Sediment sample X202
with upstream segment of
surface water pathway in
the background.

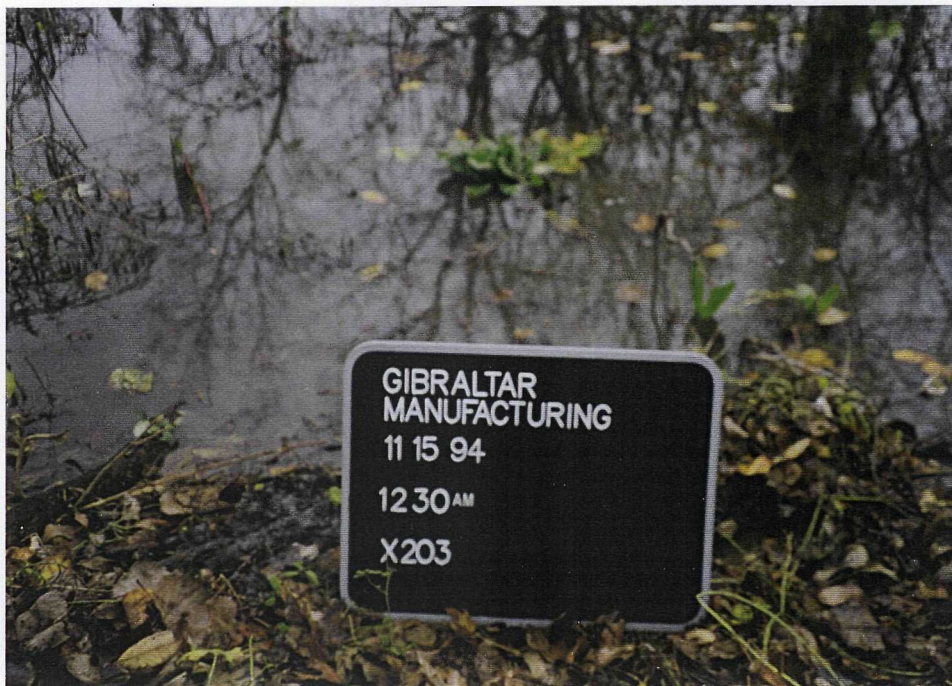
PHOTO TAKEN TOWARD:
East

Sediment sample X203 was also taken from the west bank of the stream. Leachate had been observed in this area during the

Close up of sediment
sample X203.

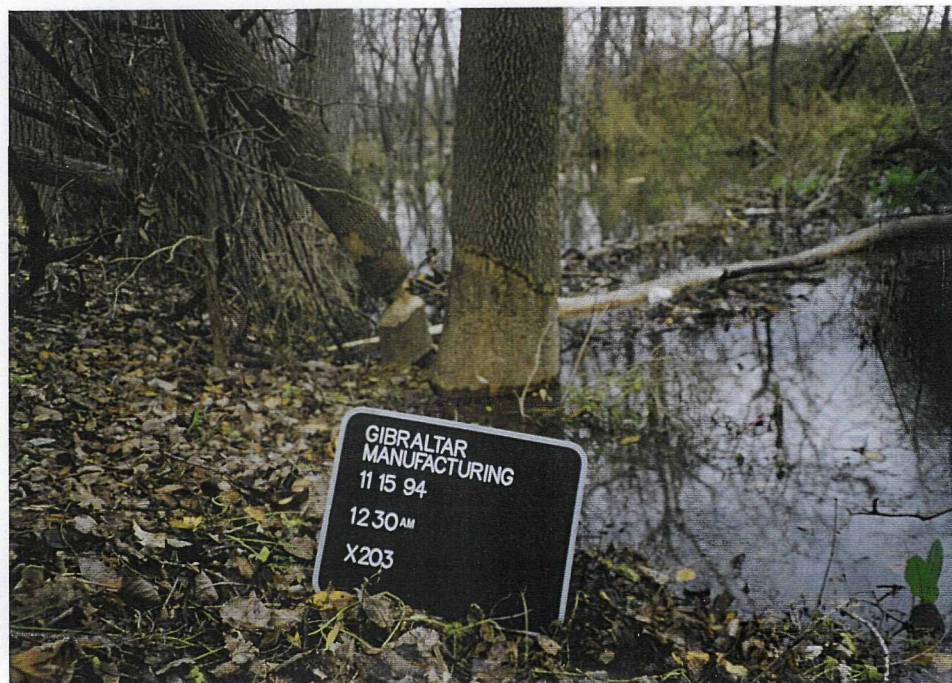
PHOTO TAKEN TOWARD:
North

Sediment sample X203
with upstream segment of
surface water pathway in
the background.

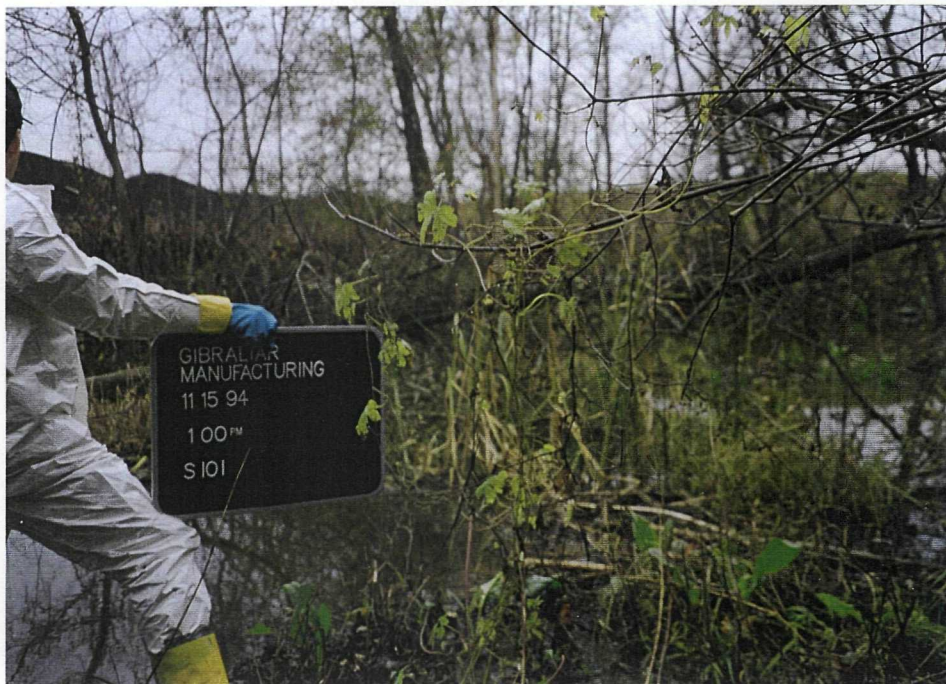
PHOTO TAKEN TOWARD:
East

Surface water sample
S101 with the Laclede
Steel Landfill in the
background.

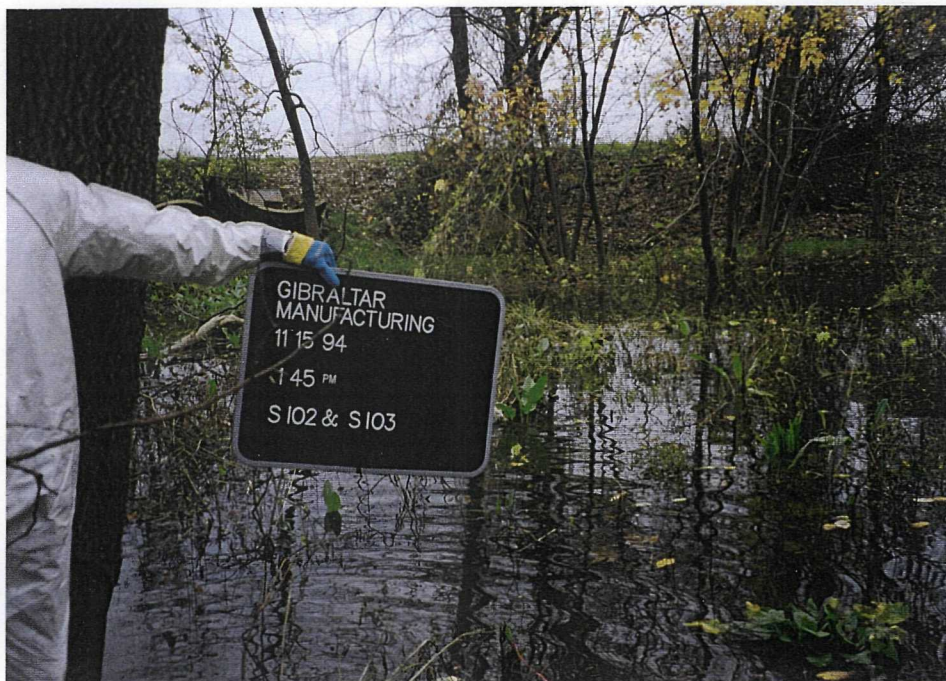
PHOTO TAKEN TOWARD:
East

Duplicate surface water samples S102 and S103 were also collected from the stream that borders the property. These samples were collected 140' upstream of southern property line of Gibraltar Manufacturing. Analysis of the samples revealed contaminants similar to those found in the background. There is somewhat of a trend towards decreasing concentrations between the two sampling points. This would lead to the conclusion that the contamination is coming from a source other than Gibraltar Manufacturing. A pipe coating operation is located upstream of the site and the Laclede Steel Landfill, which is listed on CERCLIS, is east of the site. It should be noted that some of the contaminants revealed in the analysis of S102 & S103 are the same as those found in soil samples obtained from the Gibraltar property (refer to table 3-1 for the specific analytic results of each sample).

Duplicate surface water
samples S102 & S103 with
the Laclede Steel
Landfill in background.

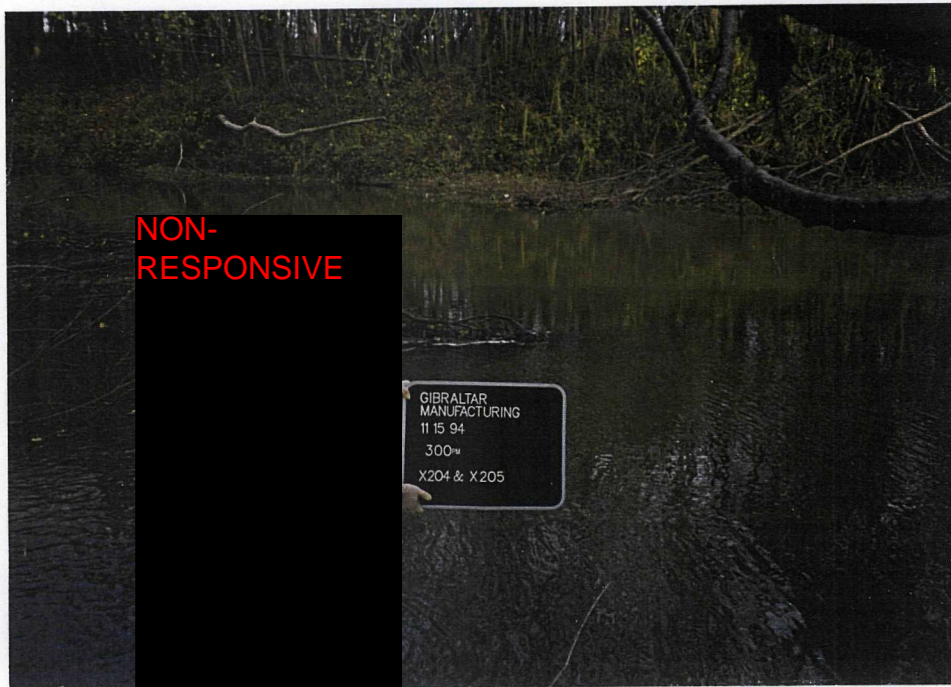
PHOTO TAKEN TOWARD:
East

Duplicate sediment samples X204 and X205 were taken at the confluence of the unnamed stream with the Wood River roughly 1/2 mile downstream of the site. The sample was taken from the top 12 inches of sediments. After the volatiles were collected, the media was mixed in a stainless steel pan in order to obtain proper duplicate samples. All of contaminants revealed in the laboratory analysis were below background concentrations.

Duplicate sediment
samples X204 & X205 with
the Wood River in the
background.

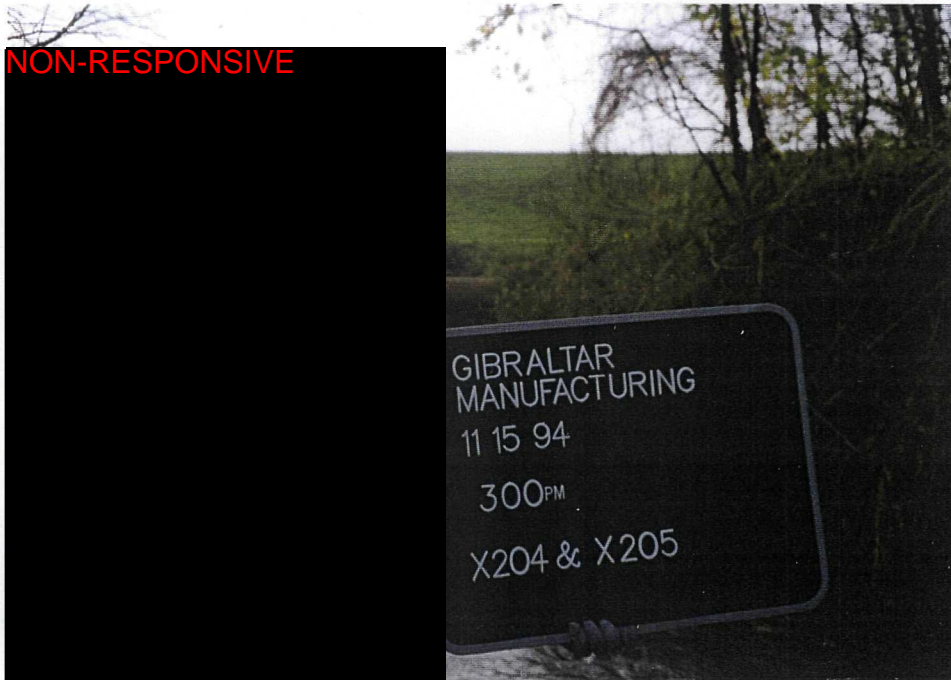
PHOTO TAKEN TOWARD:
West

Duplicate samples X204 &
X205 with the effluent
to the Wood River in the
background.

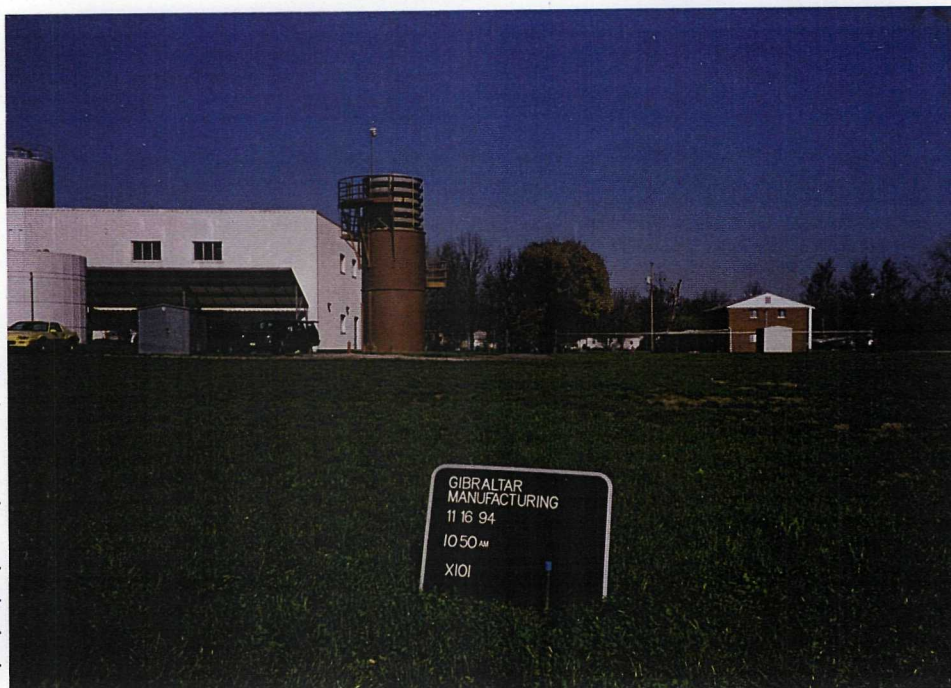
PHOTO TAKEN TOWARD:
North

Soil/Sediment Samples: Background soil sample X101 was collected from the center of the East Alton well field where groundwater samples were collected. This was chosen as the background because the soil type has been identified by the ASCS Soil Survey of Madison County, Illinois as the same type found at the site. It was collected from the top 12 inches of soil.

Background soil sample
X101 taken from an area
in the East Alton well
field with the aeration
tower in the background.

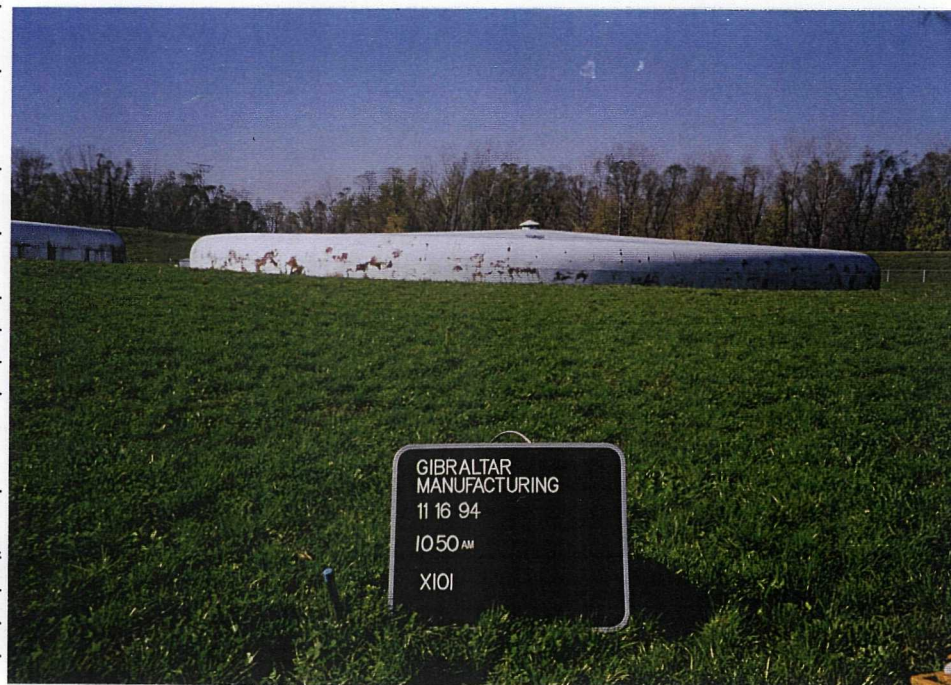
PHOTO TAKEN TOWARD:
West

Sampling point X101 with
water storage tanks at
the East Alton water
plant in the background.
